Memorandum

Subject: Habitat assessments of stream and wetland sites in the Gilpin Grasslands, Eholt Creek and the Kettle River

Date: April 27, 2015

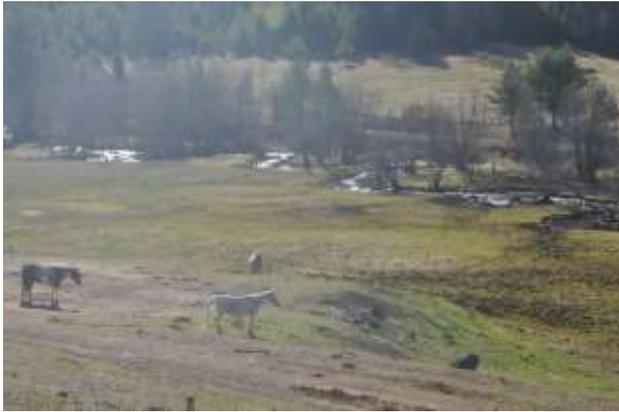
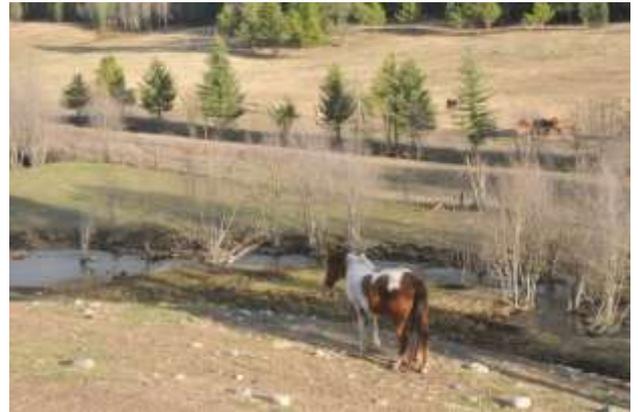
Site 1: Eholt Creek beside Highway 3

Eholt Creek is a tributary to the Kettle River. The Provincial Fisheries Information Summary System database contains no data on the creek beyond assigning it a watershed code (320-407300-34400). The stream has a natural meander pattern, gravel substrate and perennial flows and the reach would be expected to support trout and a variety of other native fish species, assuming the reach is fish accessible.

Livestock have access to the creek for over 1 km on the property and have caused extensive damage to the banks and riparian area. Some riparian trees and shrubs have survived. The riparian area would likely recover quite quickly if the livestock were fenced out of the creek through its length. Recovery of the aquatic habitat would take longer, but would occur. Recovery would consist of natural flushing of sediment from the gravel bed, deep pool formation as streamflow interacted with accumulated logs and woody debris in the channel and tree-root- stabilized banks.

1. Install a wildlife friendly fence a minimum of 5 m from the top of each bank for the entire length of the reach. In practice, due to the meander pattern, this will require a corridor of 25-30 m.
2. Install off-channel watering facilities for livestock.
3. Plant the riparian area densely with native trees and shrubs. Pioneer species should be used. These include willows (*Salix* spp.), black cottonwood (*Populus tricocarpa*), red osier dogwood, (*Cornus sericea*), Oceanspray (*Holodiscus discolor*) blue elderberry (*Sambucus caerulea*).

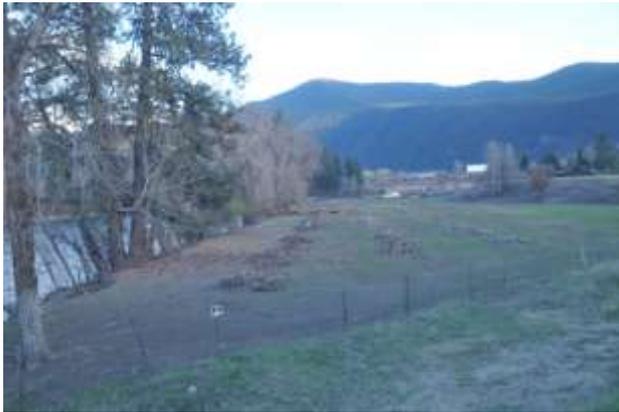
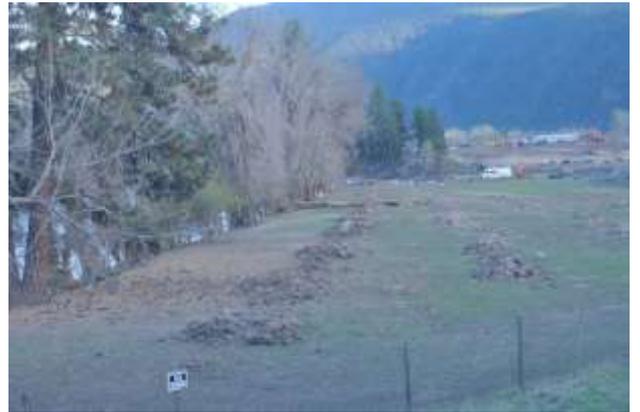
Site 2: Kettle River at Spraggett Road

This site is an unfenced floodplain pasture immediately adjacent to the main stem of the Kettle River. Windrows of uncovered manure piles are located within meters of the top of bank. Manure and nutrients will be entering the river through overland runoff and leaching of nutrients into groundwater. Significant bank erosion is also evident at the site.

1. Remove all manure piles at least 20 m from the top of bank and tarp them to avoid leaching.
2. If livestock are to be grazed on the field, install a wildlife-friendly fence at least 10 m from the top of bank.
3. Plant native trees and shrubs outside the fence at a density of approximately 4 plants per 10 square meters of area to re-establish a functional riparian area.

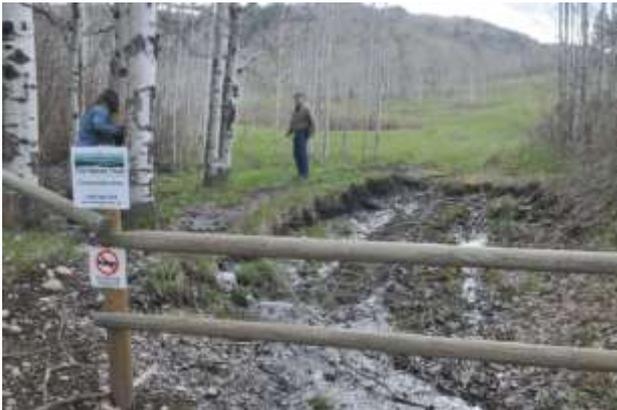
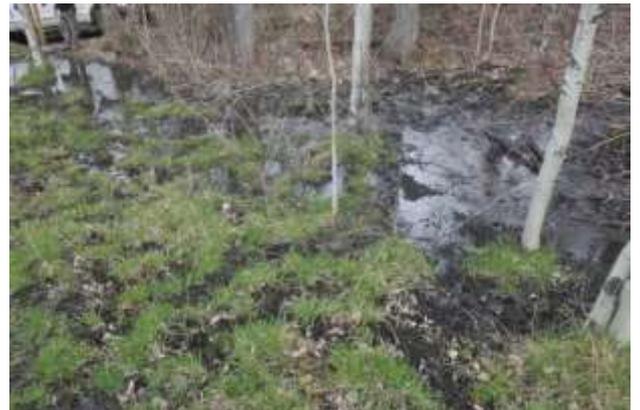
Site 3: Spring on Nature Trust property, Gilpin Grasslands

The site of the spring and its outflow channel on the Nature Trust property has been heavily impacted by cattle and off-road vehicle use. Vegetation has been trampled and significant erosion and sediment release has occurred. A small area has been fenced around the actual spring, but the fence is not wildlife-friendly, is compromised by deadfalls, and encircles only a small portion of the wetted area and adjacent riparian zone. Local stewards are working with Nature Trust staff to expand the fencing to enclose the entire riparian area this summer. The area can be expected to recover without much intervention beyond the fencing, as native woody vegetation remains intact. Little, if any planting of riparian trees and shrubs will be necessary.

1. Fence the spring and outflow channel with a setback of at least 5 m from the high water mark, where possible. The proximity of the access road will reduce the distance possible in places.

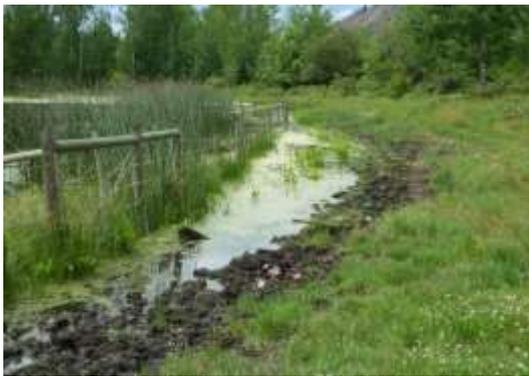
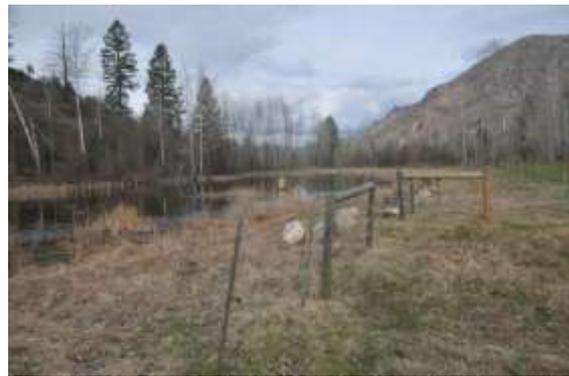
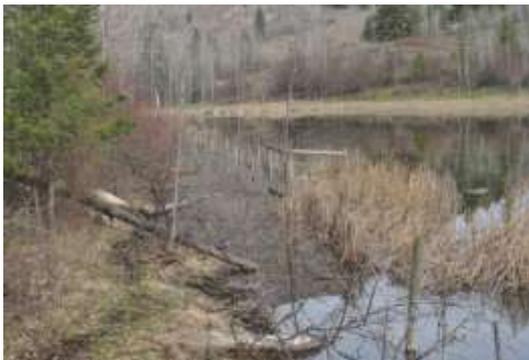
Site 4: Lost Lake, Gilpin Grasslands

Lost Lake Fencing: As originally installed (left) and with the increased setback (above).

Lost Lake is a perched wetland within the proposed Wildlife Management Area of the Gilpin Grasslands. It was heavily impacted by off-road vehicle 'mud-bogging' and livestock access. The mud-bogging had punched through the clay layer than sealed the wetland, causing it to dewater completely. The substrate was resealed using Bentonite, a livestock fence was installed, and a watering tank for livestock was installed outside the fenced perimeter. Unfortunately the fence is not wildlife-friendly and was located within the wetted perimeter of Lost Lake rather than providing a riparian setback. Local volunteers have replaced part of the fence to increase the setback and facilitate wildlife passage, greatly improving the wetland's

habitat. They hope to move the remainder of the fence out of the water in the future, as continued cattle access is damaging the riparian and shore areas.

1. Move the remainder of the fence back a minimum of 5 m from the high water mark.
2. Maintain and use the new livestock watering station located outside the fenced perimeter.

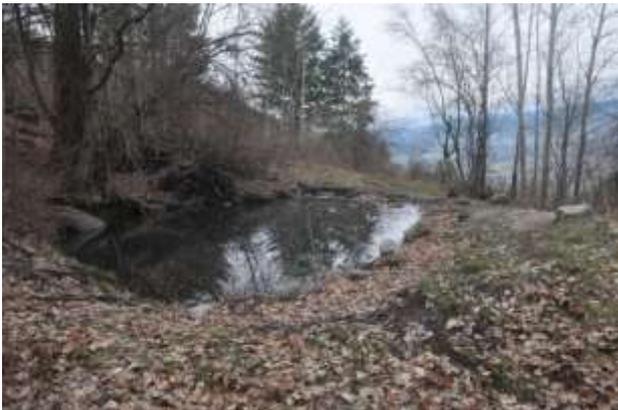
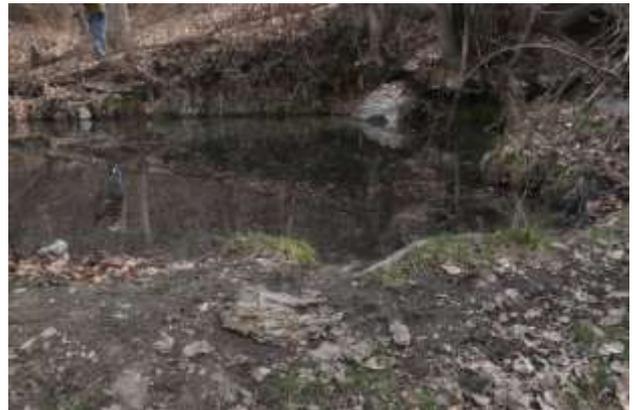
Site 5: Cattle Dugout, Gilpin Grasslands

A small pond was created by digging out a spring and using the spoil to create a downslope berm. The riparian area largely denuded of vegetation by cattle and water quality is reportedly severely impaired by fecal contamination the summer months.

1. Install wildlife-friendly fencing a minimum of 5 m from the high water mark.
2. Install a gravity-fed livestock watering station downslope of the dugout and outside the fence perimeter.

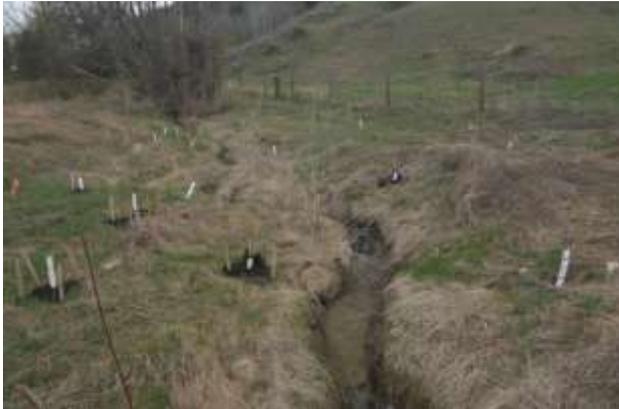
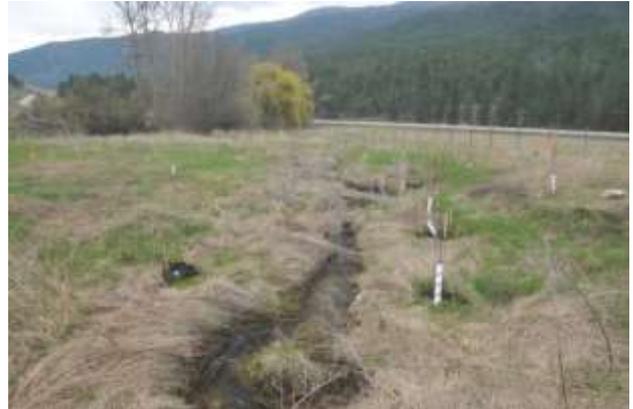
Site 6: Gilpin Creek at Highway 3

Gilpin Creek drains part of the Provincial Park exiting a steep ravine to flow across a meadow at the original Gilpin Ranch site before crossing under Highway 3 and descending a steep embankment to enter the Kettle River. The Provincial Fisheries Information Summary System database contains no data on the creek beyond assigning it a watershed code (320-192200). Fish are not documented from the creek, but may be present. In general salmonids can negotiate stream slope of up to 20 percent, which is very close to steepest section of channel between Highway 3 and the Kettle River. The culvert under the Highway appears easily passable at the moderate flows observed on April 10, 2015. A second culvert, under the trans-Canada trail is slightly perched and may form a barrier to access.

Upstream of the Highway the stream is of lower gradient, but is confined to a very narrow, fast flowing channel through a meadow. The riparian area here is securely fenced and part of it has been recently planted, primarily with black cottonwood and red osier dogwood. Upstream of the meadow, the creek is unfenced and livestock access has clearly damaged banks and the riparian area. The damage extends through the fenced portion as fine sediments clogging the gravel riffles.

1. Confirm fish presence/absence in Gilpin Creek.
2. If fish are absent, improve fish access by backwatering the perched culvert under the trail. If necessary channel slope in the short distance between the downstream end of the trail culvert and the Kettle River could be reduced by re-aligning the channel to cut across the slope. This will require an engineered design.
3. Improve in-stream fish habitat in the fenced meadow area. This could easily be accomplished by using a very small excavator widen the channel (without deepening it) and by installing logs and other large wood to produce more habitat complexity and cause scouring of deeper pools. One or two small off-channel alcove pools would also benefit fish. A detailed design would need to be developed by a qualified biologist.
4. Extend the fencing to exclude cattle from the full length of the creek.
